## **Ag Dominated Surface Water Body Categorization Report**

## **City of Colusa Submission**

Information needed to characterize individual Ag Dominated Surface Water Bodies

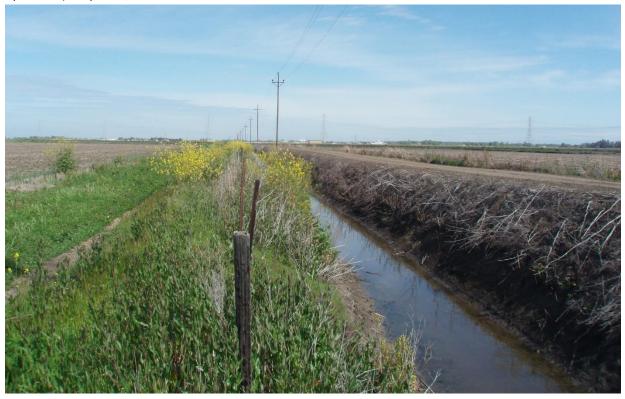
Photo 1. Unnamed Tributary to Powell Slough, downstream of effluent discharge (looking upstream) – April 16, 2012

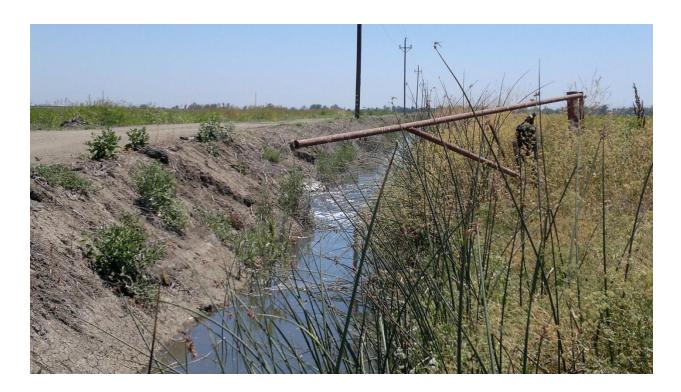
Photo 2. New Ditch (2011) upstream of effluent discharge (looking downstream) – June 28, 2012

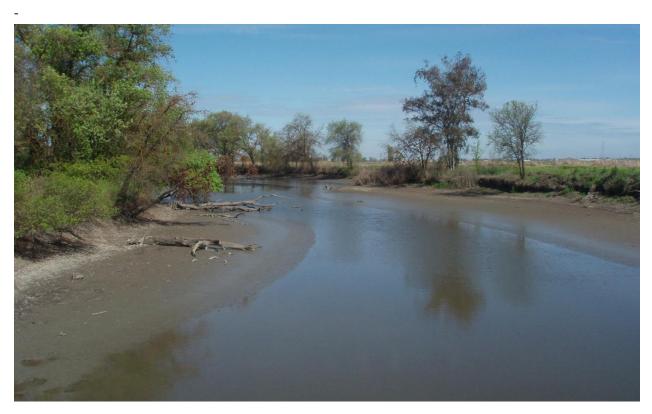
Photo 3. Powell Slough upstream of Unnamed Tributary confluence (looking upstream) – April 16, 2012

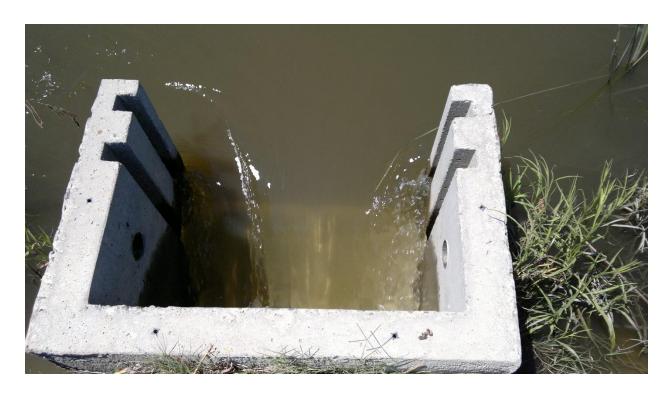
Photo 4. Weir on Unnamed Tributary, upstream of effluent discharge – June 28, 2012

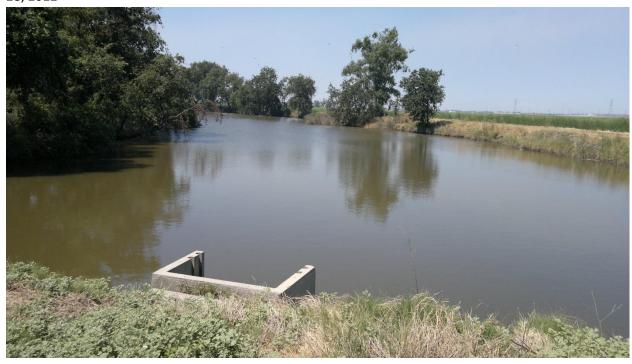
Photo 5. Weir on Powell Slough, upstream of Unnamed Tributary confluence (looking upstream) – June 28, 2012

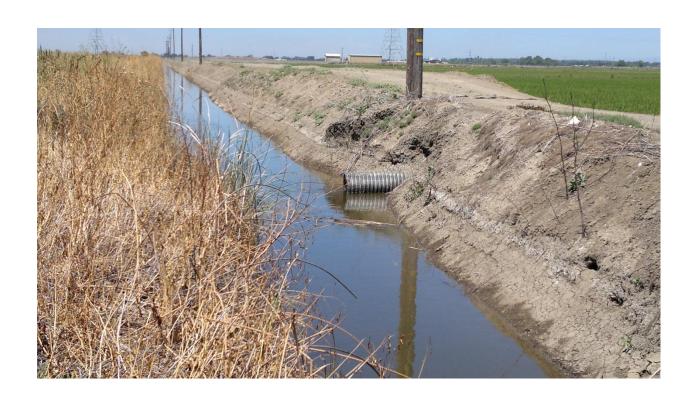
Photo 6. Field spill pipe from adjacent rice field to Unnamed Tributary (looking upstream) – June 28, 2012

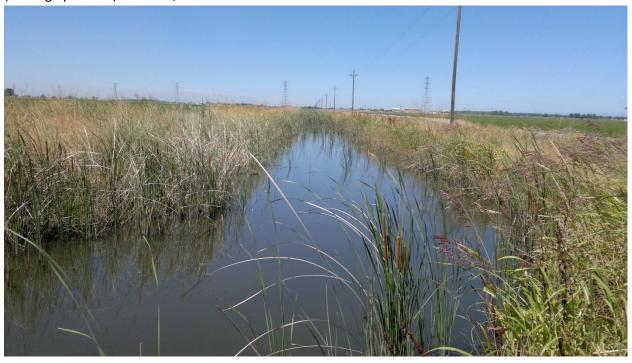
Photo 1. High Flow Period during irrigation season, Unnamed Tributary upstream of effluent discharge (looking upstream) –June 28, 2012

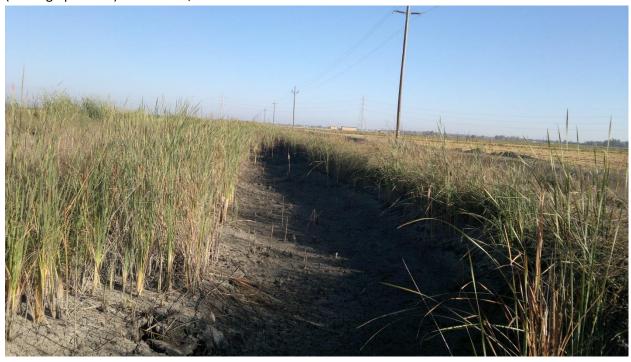
Photo 2. Low Flow Period after irrigation season, Unnamed Tributary upstream of effluent discharge (looking upstream) –October 9, 2012

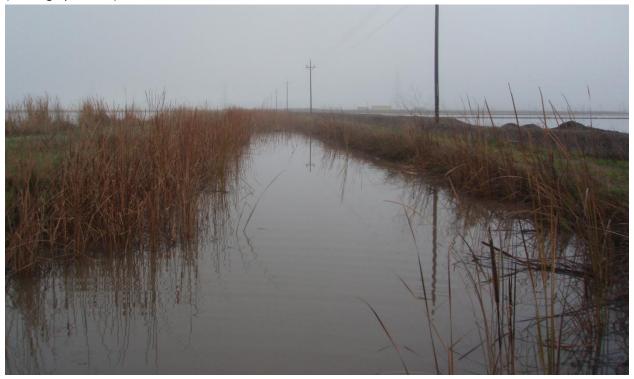
Photo 3. High Flow Period during storm season, Unnamed Tributary upstream of effluent discharge (looking upstream) –December 26, 2012

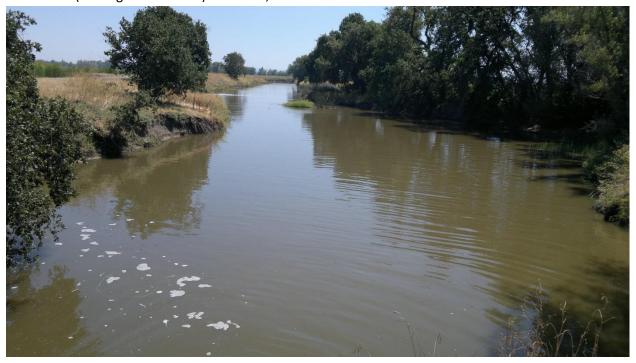
Photo 4. High Flow Period during irrigation season, Powell Slough, upstream of Unnamed Tributary confluence (looking downstream) – June 28, 2012

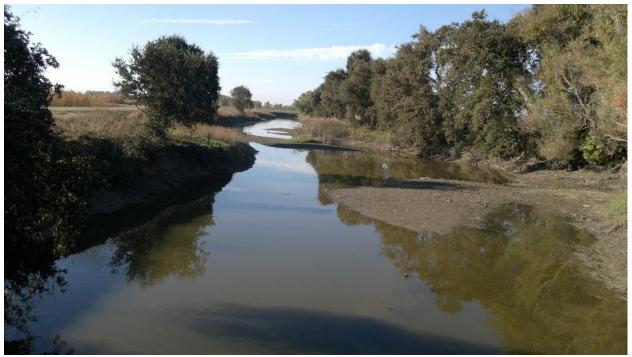
Photo 5. Low Flow Period, Powell Slough, upstream of Unnamed Tributary confluence (looking downstream) – October 9, 2012

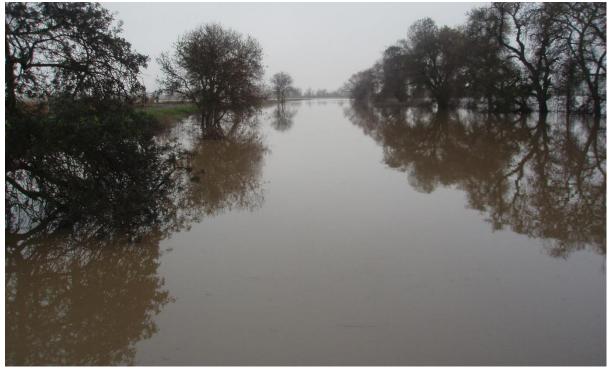
Photo 6. High Flow Period during storm season, Powell Slough, upstream of Unnamed Tributary confluence (looking downstream) – December 26, 2012
